MARINE INVESTIGATION REPORT

M99L0098

GROUNDING

PASSENGER VESSEL *NORWEGIAN SKY*
OFF ÎLE ROUGE, ST. LAWRENCE RIVER, QUEBEC
24 SEPTEMBER 1999

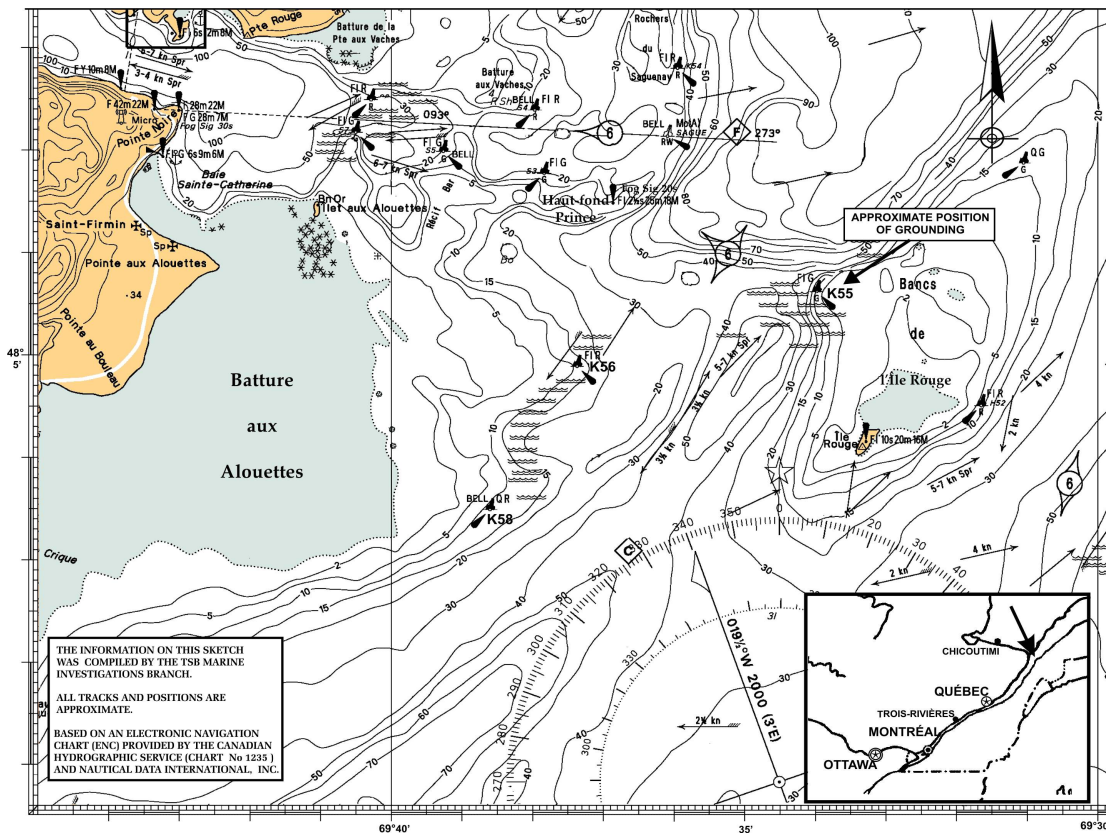
Figure 1. Approximate position of grounding

At 1154, the vessel was now headed toward the Saguenay River, stemming the tide and no longer making way. The master and the pilot agreed that there was sufficient time to turn the vessel round and still be on schedule at the pilot station. Since whales were now off the port quarter, the pilot decided to turn the vessel to port.

At 1156, the pitch of the propellers was increased and the vessel started to swing to port. There was no commercial traffic that could impede the *Norwegian Sky's* passage in the area. The cadet continued to plot the vessel's position, while the pilot monitored the radar with the same variable-range marker navigation setting.

At 1158, the vessel's heading continued to fall off to port and was now heading toward buoy K55. At 1200, the helm was turned to midship, and the propeller pitch setting was reduced from approximately half to one third. After plotting the noon position, the cadet informed the master that the vessel was nearing the shoal near buoy K55. When the master expressed concern that the vessel was coming too close to the shoal, the pilot assured the master that the situation was under control.

The pilot believed the vessel to be some four cables downriver of buoy K55 and the flood tide to be setting 210°T at some two to three knots. At 1202, the master increased the pitch on the starboard propeller from 31% to 48%, and the rate of turn to port gradually increased.

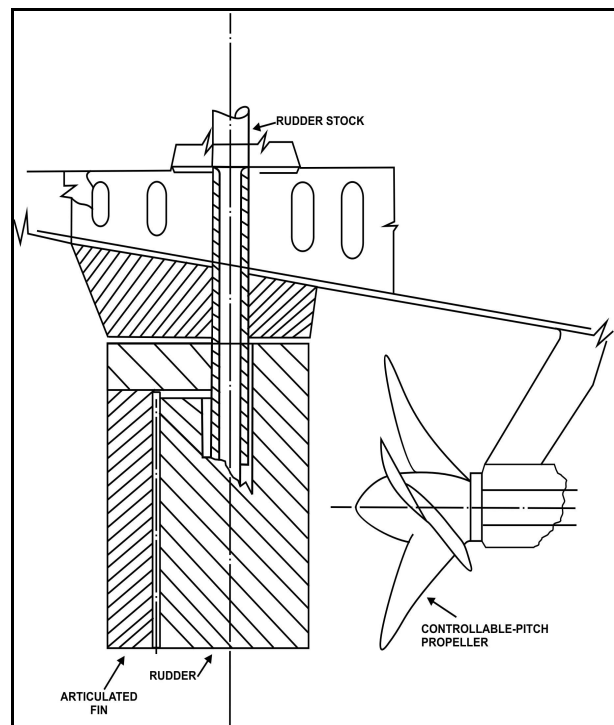
Figure 4. Typical section in way of rudder

Unlike the steering and propulsion system of a conventional vessel, which has a single rudder and a single propeller, the *Norwegian Sky* is equipped with a twin-rudder and twin-propeller system. To further enhance manoeuvrability of the vessel, the rudders are Becker design, semi-balanced, underhung units that incorporate a vertical, articulated flap in the after part of the rudder. When the helm is put over, the main rudder can be set at any angle up to 35° (at sea) or 45° (in harbour). As the main rudder rotates, the flap automatically articulates in the same direction, thereby increasing the maximum rudder angle.

At 35° of helm, propeller thrust is diverted laterally, thereby creating an athwartships thrust similar to a thruster. This attribute may be very useful when manoeuvring in harbours but hazardous once the vessel has left its berth and proceeded down the river. When under way in a restricted waterway, there is no defence mechanism in place to prevent the application of excessive helm and no audio alarm to warn the navigator of excessive helm use, nor are there secondary measures (such as a warning placard or a cautionary note in the *Deck Procedures Manual* or pilot card).

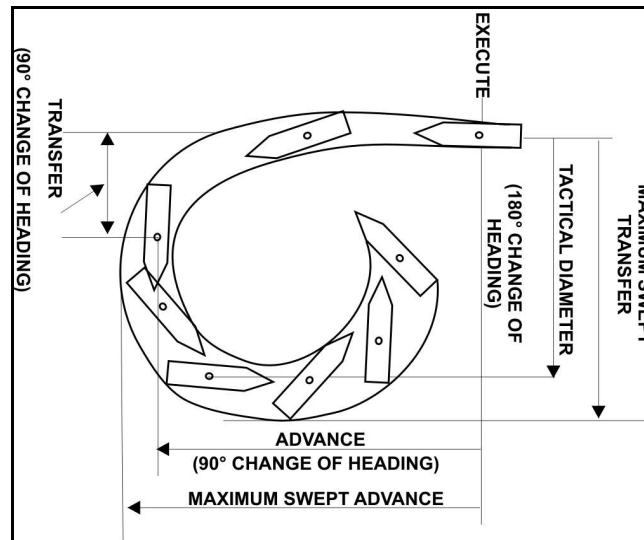
Figure 5. Swept-path diagram

little information on how much space a ship requires. The swept path is most useful for ship handlers when estimating potential clearance with waterways, other vessels, and obstructions. The maximum swept advance and swept transfer are greater than the ordinary advance and transfer.¹⁰

A pilot card was posted on the after bulkhead of the wheelhouse, behind the central integrated bridge system (IBS) workstations. The card indicated the use of hard-over helm at 35° and 45° for sea and harbour applications, respectively, and showed a swept-path diagram. However, the information was limited to the turning circle data and did not contain swept advance and transfer data with corresponding helm angles.

Based on their experience, acquired during sea trials of the *Norwegian Sky*, navigation personnel advised the pilots that 20° helm action was equivalent to hard-over helm and that 1° or 2° was sufficient helm action for most course alterations. Moreover, the master discouraged the use of hard-over helm.

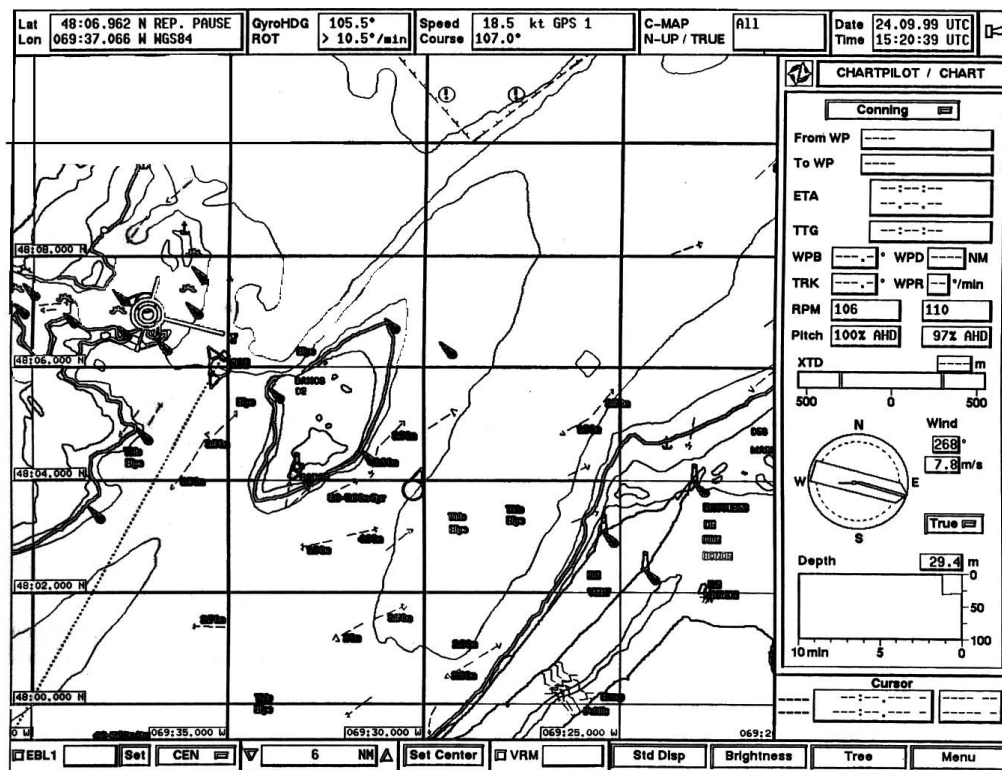
Figure 9. ECS presentation

The ECS on board was an ECDIS nautical planning and consulting station.¹⁴ This system enables the navigator to define and select a number of inclusion and exclusion zones, in which the computer will initiate automatic specific target tracking on the vector chart while defining channel limits and reducing operator workload. Important video and audio alarm signals can be selected to indicate if the vessel leaves these predetermined parameters. These alarms are easily recognized, even if the navigator is some distance away from the display. The radar image can be superimposed onto the ECS display.

The ECS was in operation for all bridge team members to use, but the team only glanced at the monitors. The system was equipped with the most recent electronic navigation vector charts issued by the distributor, CMAP, in 1999. The pilots did, temporarily, overlay the radar presentation on the ECS presentation but found discrepancies in shoreline features and

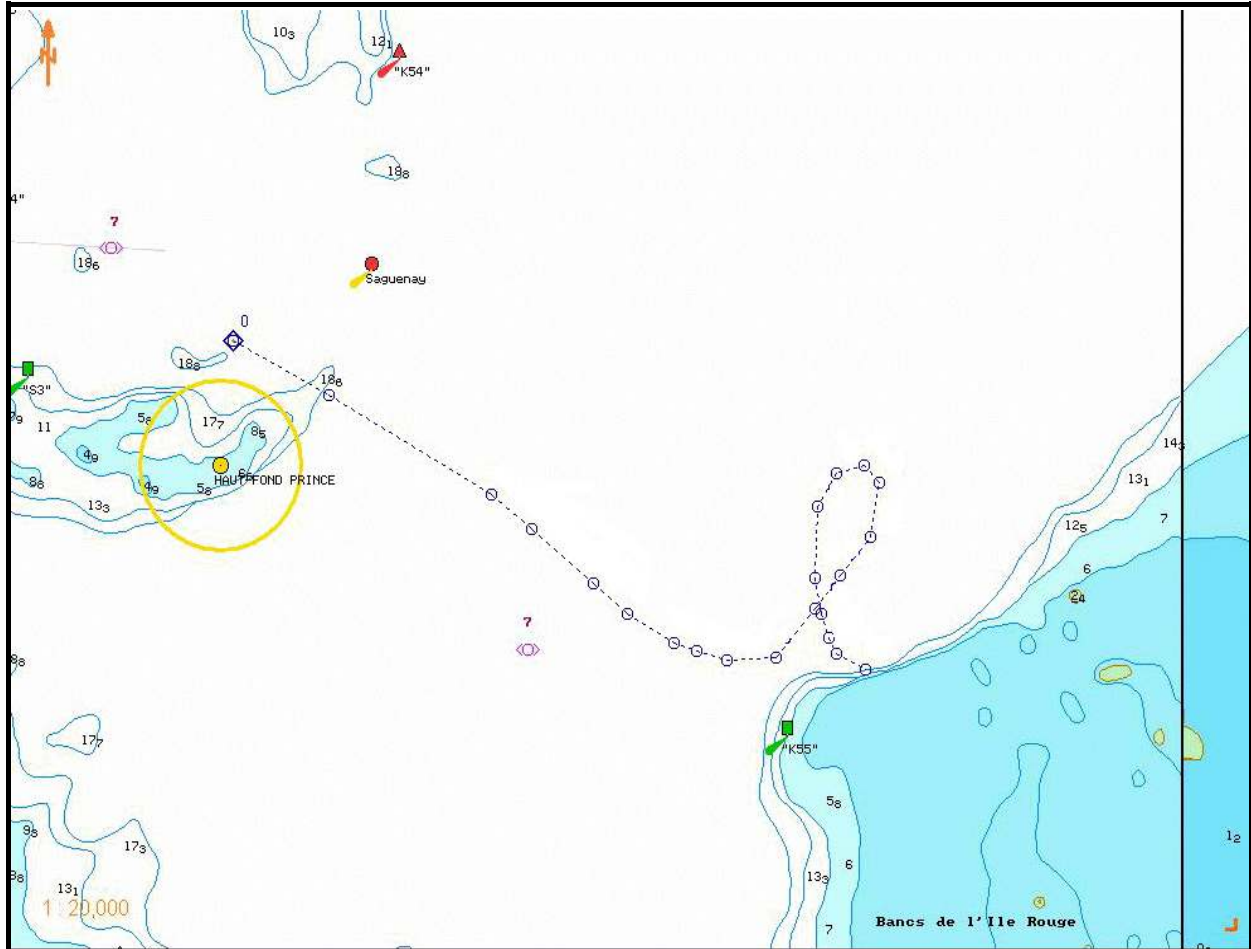
Appendix A: Track of the Norwegian Sky

Using the Pointe Noire range, the pilot conducted the vessel down the buoyed channel. At about 1120, near buoy S3, helm orders were given to steer a course of 115°G (the gyrocompass error was negligible) for buoy K55. The pilot adjusted the radar variable-range marker to two nautical miles (nm) and asked the master to gradually reduce the vessel's speed. The master moved the speed levers and oversaw progress of the vessel by visual observation. Near the Bancs de l'île Rouge (Rouge Island Banks), at about 1133, the pilot noticed that the target of Haut-fond Prince (Prince Shoal) light was nearing the variable-range marker and that whales were now grouped downriver of buoy K55. Consequently, he ordered the helmsman to turn the helm 20° to port to head toward Les Escoumins pilot station. At about 1141, the vessel settled on a course of approximately 030°T, heading toward the pilot station. At approximately 1148, the pilot realized that the whales were now abaft the port beam and, therefore, ordered 20° port helm (See Appendix A).

Track of the *Norwegian Sky* recorded by the ECS on board (section of ENC chart CHS 1203)

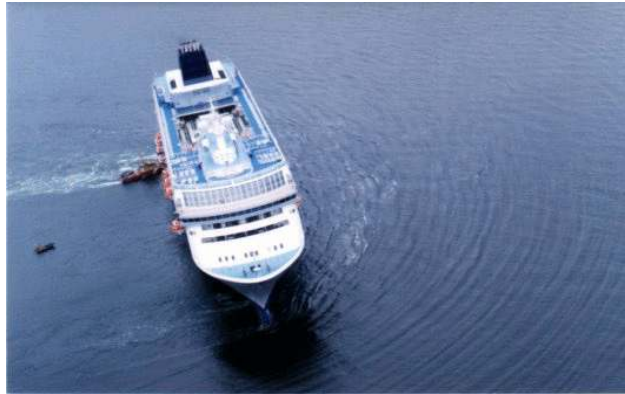
Photo 2. *Norwegian Sky* aground. Note current pushing the vessel against the Bancs de l'île Rouge

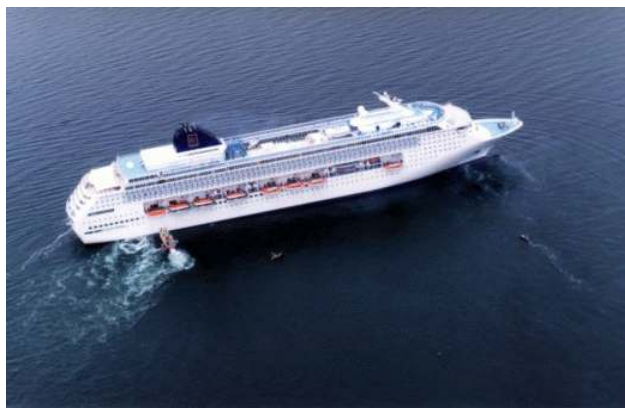
Photo 3. *Norwegian Sky* aground, Coast Guard Cutter *Isle Rouge* assisting
